## A case of photomultiplier tube defect observed in gamma camera DMSA scintigraphy: The importance of regular quality controls

Serdar Sedat Işık<sup>1,2</sup>

Işık SS. A case of photomultiplier tube defect observed in gamma camera DMSA scintigraphy: The importance of regular quality controls. D J Med Sci 2019;5(4):8-14.

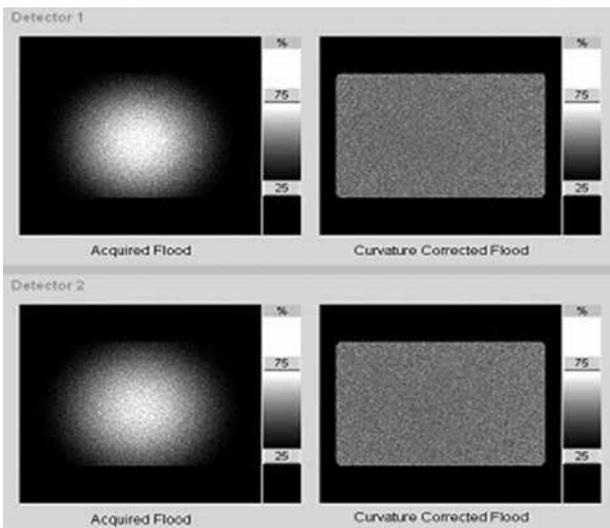
**Figure 2.** Normal intrinsic homogeneity test with 30,000,000 counts and valid results before starting daily imaging.

Dimercaptosuccinic acid renal scintigraphy tests were conducted on a day of study in which the daily peaking/tuning tests of the dual-head SPECT gamma camera showed visually and quantitatively normal results (Figure 2 and 3) of intrinsic (useful field of view [UFOV] 2.08%, central field of view [CFOV] 1.75%) and extrinsic homogeneity tests, which were conducted before routine procedures at the nuclear medicine department. After patients were administered intravenous DMSA, about 3-4 hours later, anterior-

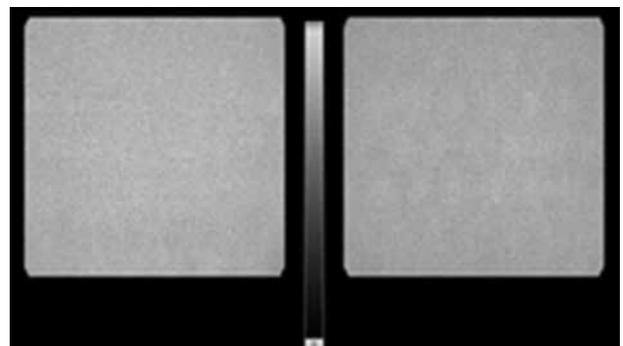
**Figure 3.** The appearance of extrinsic homogeneity test with 20,000 counts performed on both detectors in order to determine collimator damage, after starting daily imaging following initially normal tests,

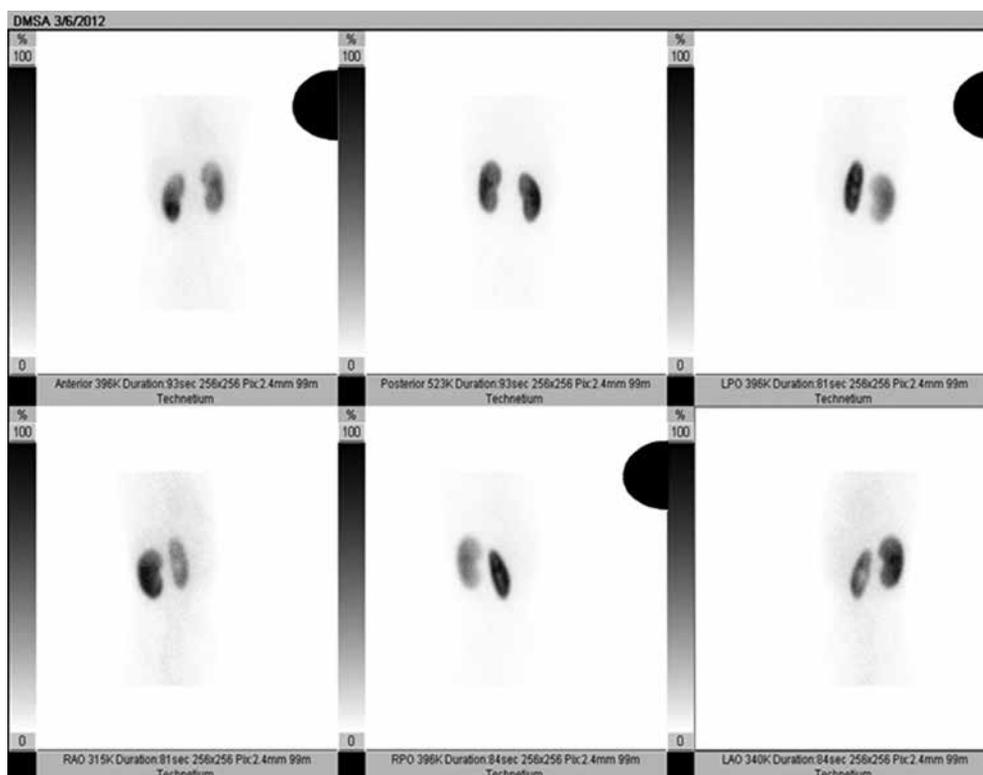
posterior, lateral and oblique spot images of the abdomen were taken at different angles under the gamma camera so that the kidneys entered the visual field. Images taken by the gamma were created by collecting 500,000 counts (photons) for each position. During DMSA static kidney imaging, in the images obtained with detector-1, there was an area that was noticeably reflected on the images and could not be counted in the upper right side of the image, which drew our attention (Figure 4). This error which manifested in images suggested a defect in the photomultiplier tube. As a result, after images of all patients were completed, quality control tests were repeated. Peaking/tuning tests showed that peaking had been performed but tuning process had not. In repeated intrinsic and extrinsic homogeneity testing (Figures 5a-c), there was a prominent tube defect that caused non-homogeneity in detector-1 (Intrinsic: UFOV 99.93%, CFOV 66.60%).

**Figure 4.** Three hours after  $Tc^{99m}$  dimercaptosuccinic acid injection, images obtained by collecting 500,000 counts (photons) for each detector and position in anterior, posterior, right and left anterior and posterior oblique, right and left lateral imaging of the kidneys under gamma camera. In the images obtained with the number 1 detector, the semi-circular area in the right quadrant that could not be counted suggested photomultiplier defect.

After the service engineers of the device were notified, certain quality control tests were repeated and confirmed that there was a defect in the photomultiplier tube that was related to the problematic area in the detector. After the source of the problem was identified, the photomultiplier tube was replaced with a new one, peaking/tuning was performed, and the problem

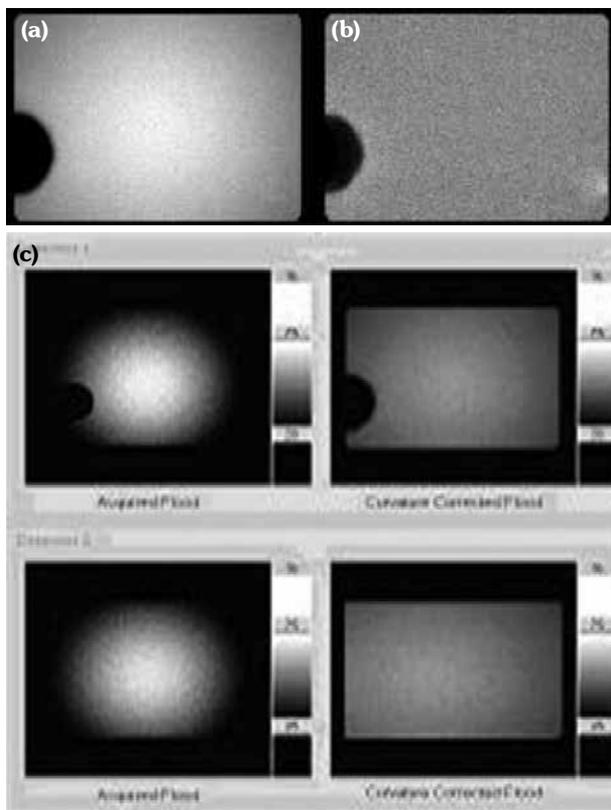
**Figure 5.** The quality control tests to confirm suspicion of the photomultiplier tube defect: **(a)** appearance of homogeneity and photomultiplier tube defect as a result of intrinsic homogeneity test with 30,000,000 counts; **(b)** appearance of homogeneity and photomultiplier tube defect as a result of extrinsic homogeneity test with 5,000 counts with LEHR collimator attached, and **(c)** image obtained from intrinsic homogeneity test with 30,000,000 counts for each detector (non-homogeneous for detector 1, homogeneous for detector 2) and quantitative homogeneity values for each detector. FOV: Field of view.

Before patient admission, 30  $\mu\text{Ci}$   $\text{Tc}^{99\text{m}}$  control point source was prepared in a plastic dish an intrinsic homogeneity test was performed to collect 30,000,000 counts from both detectors. Results of the intrinsic homogeneity test revealed that the images obtained from both detectors were visually homogeneous, that the quantitative homogeneity values supported the visual results, and the quantitative homogeneity values were between 1.24-2.08% (Figure 2). At the same time, in order to determine visual detection of collimator damage which may have occurred to the gamma camera when the low energy high resolution (LEHR) collimator was attached as well as determine the homogeneity of the detectors together with the collimator, extrinsic homogeneity test was performed by collecting 20,000 counts from each detector, using planar  $\text{Co-57}$  source with 15 millicurie (mCi) activity. According to the visual obtained by the extrinsic homogeneity test, it appeared to be homogeneous and no collimator damage could be distinguished (Figure 3). In the images obtained with the number 1 detector during DMSA kidney imaging in the gamma camera throughout the day, an area that could not be collected on the upper right side of the image which clearly manifested in the images was noticed (Figure 4). When the images were carefully examined, a defect in the photomultiplier which corresponded with the related area came to mind. As a result, after the imaging of the patients was completed, quality control tests were repeated. Homogeneity of the detectors was reassessed with control intrinsic and extrinsic homogeneity tests (Figure 5a-c). By using 30  $\mu\text{Ci}$   $\text{Tc}^{99\text{m}}$  radioactive point source, intrinsic homogeneity test with 30,000,000 counts of UFOV and CFOV showed that homogeneity values of detector 1 varied between 42.52-99.93%, that it was not visually homogeneous, and that homogeneity values of detector 2 ranged between 1.27-1.89% and were visually homogeneous. Quantitative homogeneity values for detector 2 were below the NEMA standard of 2.5-3.5%. Quantitative homogeneity values for detector 1 were particularly high and passed the NEMA upper limit values (Figure 5c).

Similarly, when UFOV of detector 1 and detector 2 and the integral and differential homogeneity values within the central field of view corresponding to 75% of this area were compared for both detectors, the homogeneity values of detector 1 was significantly high compared to detector 2. This is because, although intrinsic homogeneity images and quantitative homogeneity values of detector 2 were normal and valid, the reason that detector 1 did not have homogeneous appearance and especially high quantitative homogeneity values compared to detector 2 was because there was a defect in the photomultiplier corresponding to the upper left quadrant of the detector. Therefore, quantitative homogeneity values of detector 1 were higher than the quantitative homogeneity values of the number 2 detector, since no counts could be taken in the crescent moon-shaped black area visible in the upper left quadrant of the images corresponding to the photomultiplier tube of detector 1 (Figure 5c). However, in the extrinsic homogeneity test performed with the planar Co-57 source with the LEHR collimator installed in detector 1, the homogeneity and defect image obtained with 5,000 counts were reconfirmed (Figure 5b).

Although various companies report that corrected homogeneity values can be accepted up to 5%, it should be less than 2.5% according to NEMA standards. The homogeneity values obtained in the quality control intrinsic homogeneity studies of the gamma camera were very high and similar values were obtained in the repeated homogeneity studies. Since it is known that the acceptable homogeneity values should be maximum 2.5% and the defect in the photomultiplier tube was identified in detector 1, the defective photomultiplier tube material was replaced and renewed (Figure 6). According to the results obtained visually and quantitatively in the repeated quality control intrinsic and extrinsic homogeneity tests, the images obtained for each detector were homogeneous, and the quantitative integral and differential homogeneity values were between 1.22-1.86% for the intrinsic homogeneity test, and between 1.44-2.88 for the extrinsic homogeneity test; these results were found to be within the standards of NEMA and below the specified reference values (Figures 7a, b).

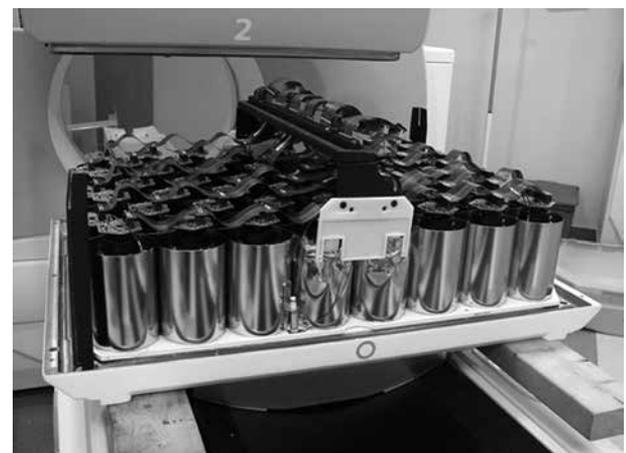
**Figure 6.** Replacement of the faulty photomultiplier tube of detector 1 with a new one.

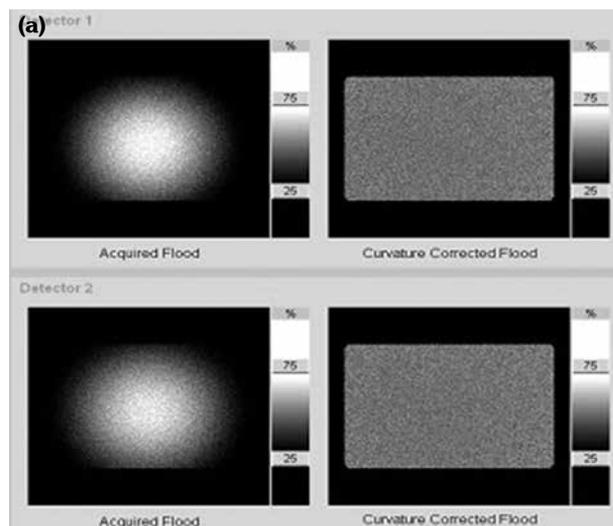
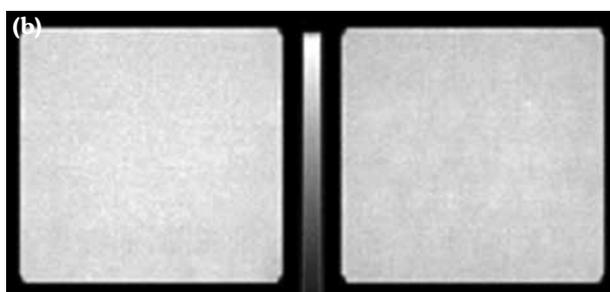
was not re-encountered (Figure 6). After the photomultiplier tube was replaced, intrinsic and extrinsic homogeneity test showed that the non-homogeneity was corrected and a homogeneous image was obtained (Figure 7a, b).

**Figure 7.** The homogeneity images and quantitative homogeneity results obtained by quality controls performed after replacing the defective photomultiplier tube of detector 1; **(a)** intrinsic homogeneity study with 30,000,000 counts; and **(b)** extrinsic homogeneity study with 120,000,000 counts when gamma camera detectors were fitted with a low energy high resolution collimator.
